"Full" Reserve Study

Coronado Country Club Estates El Paso, TX

Report #: 40185-0
For Period Beginning: January 1, 2021
Expires: December 31, 2021

Date Prepared: November 4, 2020

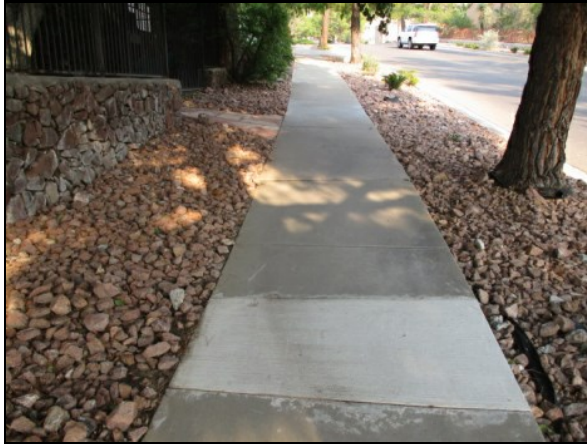
Comp #: 103 Sidewalks - Cut/Repair 10%

Useful Life:
5 years

Remaining Life:
4 years

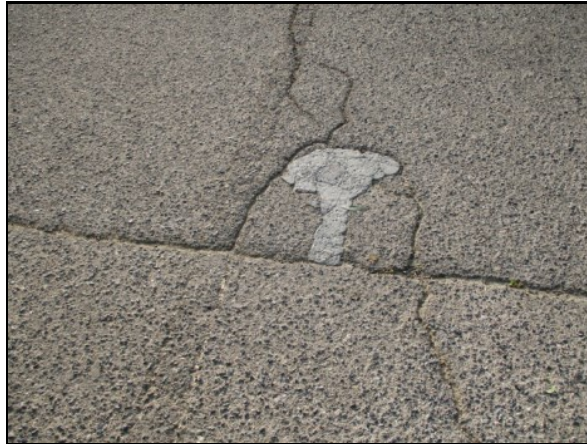
Comp #: 202 Asphalt - Seal/Repair

Useful Life:
5 years

Remaining Life:
0 years

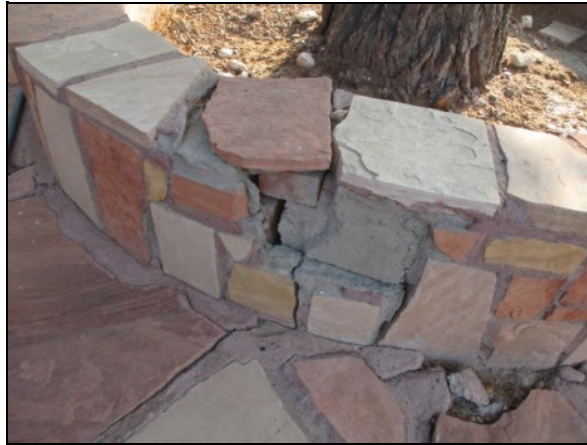
Comp #: 209 Stone Decking - Repair

Useful Life:
10 years

Remaining Life:
0 years

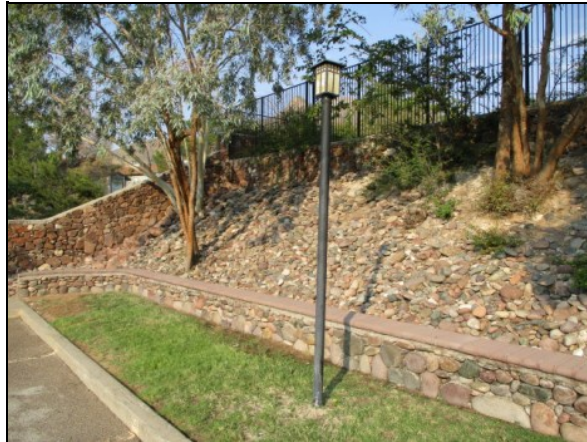
Comp #: 320 Pole Lights - Replace

Useful Life:
25 years

Remaining Life:
5 years
